#### **TEST REPORT**

**Report No.**: F7299.01-109-47

**PRODUCT TYPE**: Polyvinyl Chloride (PVC) Picture Window

**SERIES/MODEL**: HM155

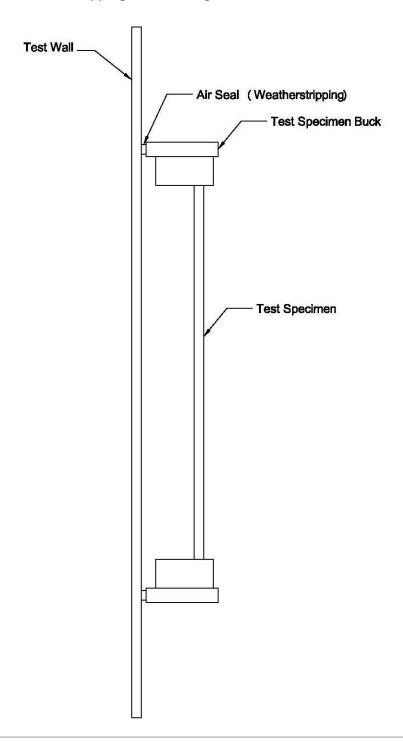
#### **Appendix B**

**Location of Air Seal**: The air seal between the test specimen and the test wall is detailed below. The seal is made of foam weatherstripping and is attached to the edge of the test specimen buck. The test specimen buck is placed against the test wall and clamped in place, compressing the weatherstripping and creating a seal.
